Reverse osmosis sea water  
desalination plant.

450 m<sup>3</sup>/hour, 10,800 m<sup>3</sup>/day

## DRINKING WATER FOR THE ISLAND OF LIPARI

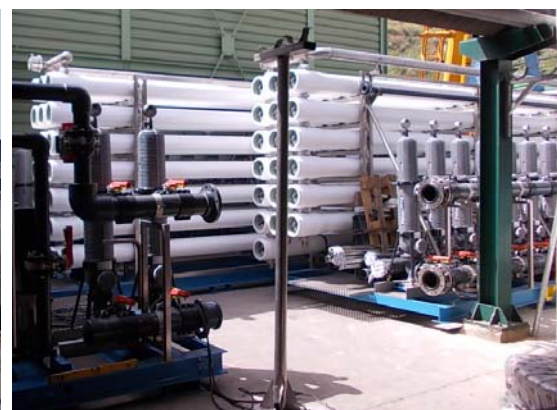
*The photos show a view over Lipari Island (top), part of the equipment being delivered to the island (left) and one section of the drinking water plant during installation (right).*

The water treatment plant is a skid mounted reverse osmosis (RO) desalination plant producing drinking water from sea water and was designed to work with power supplied by a photovoltaic system. The unique configuration of the plant optimizes performance and also ensure easy access for management and maintenance of the equipment.
